CASE STUDY:

TRACKTEX TURNOUT

**FEILDING, MANAWATU REGION
NEW ZEALAND
APRIL 2018**

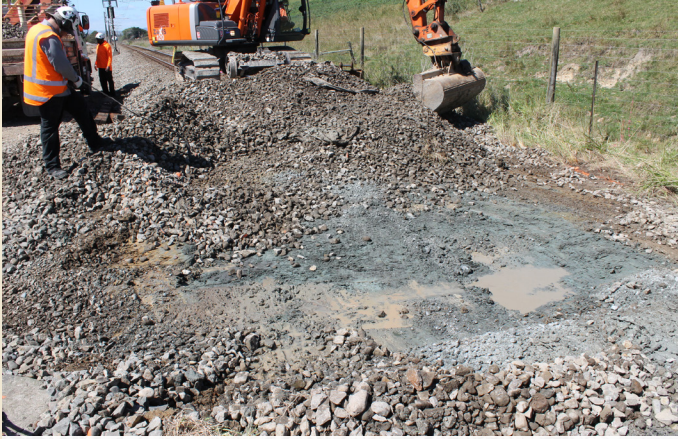
Initial preparation at South end of the site, showing the subgrade condition.

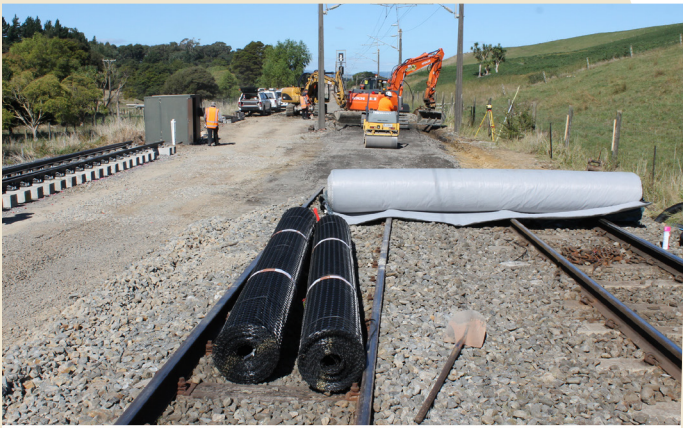
Subgrade preparation prior to product installation.

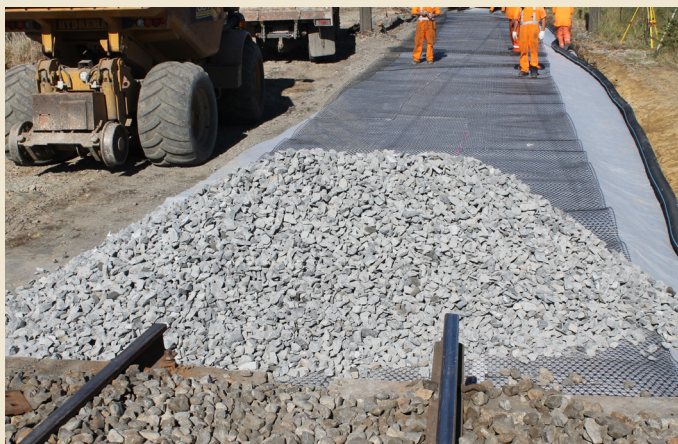
Ballast being laid on top of installed product.

Tracktex was then placed on the prepared subgrade, with overlaps of 1.5 m, Tensar TriAx170 then placed directly on top followed by a 300 mm layer of 40-80 mm ballast. Replacement sections of new rail and concrete sleepers (four sections each 14 tonne) were then replaced and re-welded together, followed by top up ballast to final level.
