CASE STUDY:

WOBURN TRACKTEX TURNOUT

**LOWER HUTT, WELLINGTON
DECEMBER 2017**

**CLIENT: KIWIRAIL
CONTRACTOR: ACTION CIVIL LTD**

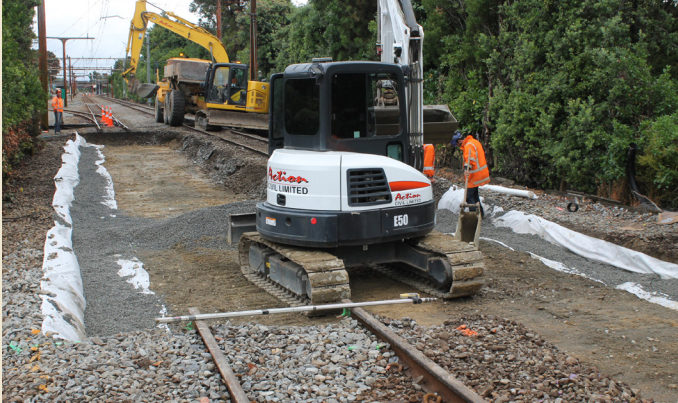
Removal of ballast, preparation of site, subsoil drain install.

The contractor involved is experienced with similar installations under ballast (as above), in this instance the relevant rail sections were first removed by KiwiRail. The contractor then removed the ballast and reshaped the subgrade. Subsoil drains were then cut beside and across (in this instance) the tracks, lined with a non-woven geotextile, and backfilled with P-metal, before wrapping the geotextile over the top.

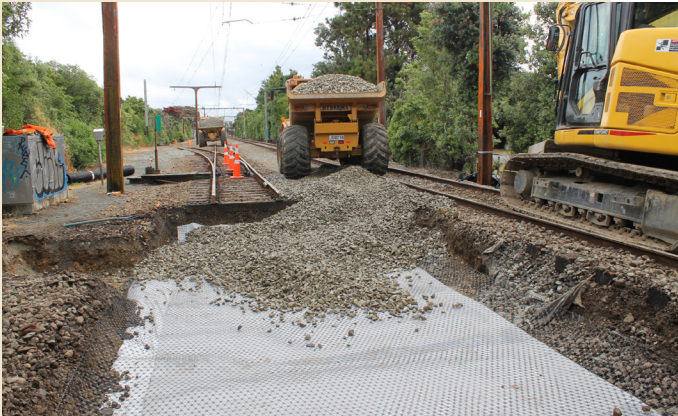
Install of Geocomposite Tracktext™ followed by Tensar TX170 geogrid.

Tracktext™ (3 rolls of 3m x 25m used on this site) was then installed over the prepared subgrade, any overlaps were a minimum of 1.5m, and Tensar TriAx170 geogrid (2 rolls of 3.8m x 50m used) was then placed directly on top. New ballast was then placed on top of both products and spread by an excavator. The ballast fill level was 340mm, allowing an extra 40mm for settlement. This ballast was placed along with the use of a laser level, with constant readings to ensure the ballast was level and to the height required. New concrete sleeper and rail sections were then placed into the new areas by KiwiRail.

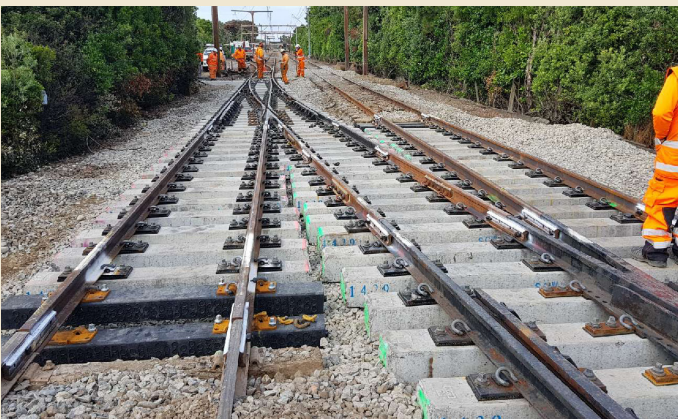
New concrete sleeper and rail sections were placed into the new areas by KiwiRail.
