# CASE STUDY

Erosion Control

Project: Ohope Road Slip  
Date: June 2011  
Client: Whakatane District Council  
Location: Whakatane

## MacMat-R®

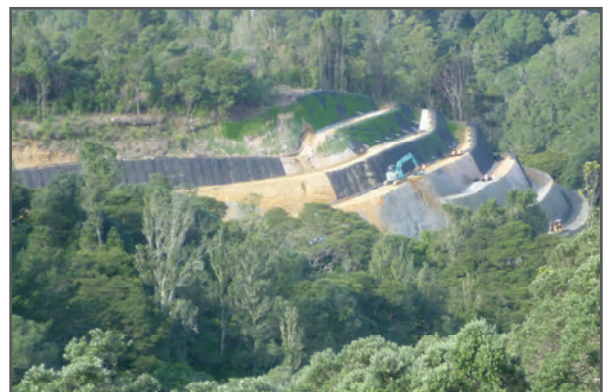
During construction on the roadside

The slopes were benched in a series of lengths up to 25m long. MacMat-R® was anchored in trenches at the top of the bench and into a metal filled drainage channel at the base. Face anchorage was achieved with 1m long galvanised steel pins at 1 metre centres. Due to the steep nature of the slopes, up to 80 degrees in places, a significant tensile load could potentially be applied to the product.

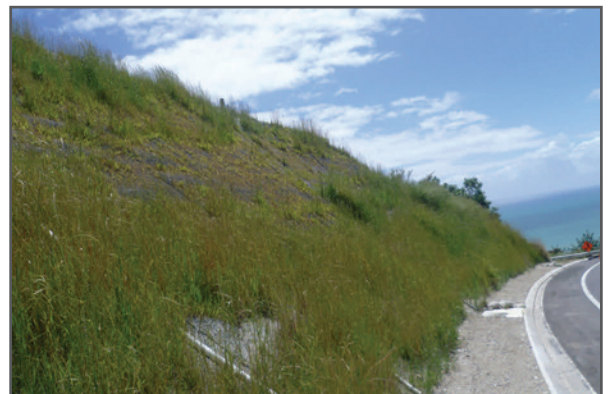
Greened up slope following construction

It was winter by the time the slopes were hydro-seeded however within a very short period of time, germination was achieved and grass grew evenly through the product.

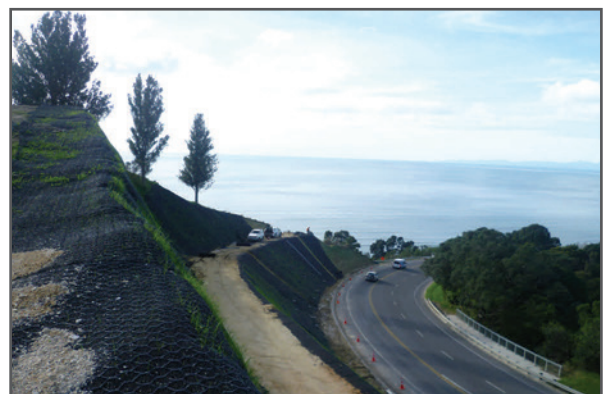
Completed MACMAT-R slope prior to hydro-seeding

The selection of MacMat-R®, a turf reinforcement mat that incorporates a PVC coated double twist mesh, ensured that the tensile strength requirements for this site could be adequately met. Being a composite product it also meant that only a single layer installation was required, reducing installation speed, cost and storage space requirements on site.
